Scope of work for job:

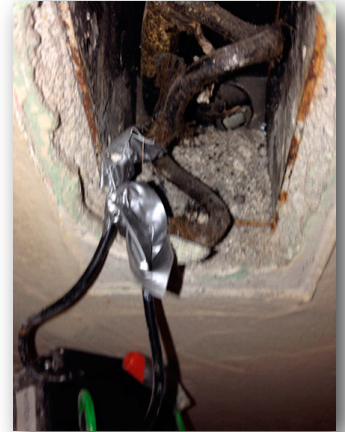
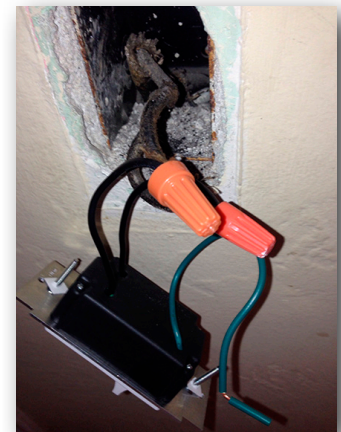
*2) Open all house outlets and fixtures to check for loose connections/dangerous splices;-see pic; fix as needed.*

**-result B:** Opened everything but newish work in garage: all ok wiring wise but many outlet boxes in house / outlets fitting / seating is crumbly/loose: Necessitates more finishing work then there could be for any that are replaced. Most old boxes are metal as well, and ungrounded. Recommend grounding. Much more old wiring found then expected.

**-result C:** Found 2nd Subpanel ( old ) in garage with lots of old wiring; partial locator test of its circuits revealed it's mostly serving garage. IE time to completely isolate each circuit not allocated.

**-result D:** Finding of 2nd Subpanel necessitated inspection of main panel: discovered that apparently approximately 1/3-1/2 of house is running from old 30amp shared neutral breaker. Please google the phrase " Shared Neutral " or speak to your electrician. This breaker / circuit should be replaced / repulled. Not a recommended configuration for modern day electric use / circuit design. Can result in overload to neutral, not good when combined with old wires. Speak to an electrician; here's a link if you are curious now....

**Recommend partial house rewire, replace main panel. Load balance to / with kitchen Subpanel.**

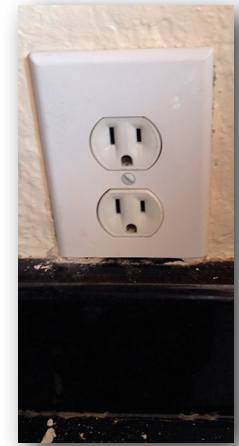
3) *Cover and reseal loose kitchen outlet. Test if served by GFCI.*

**-result A:** Reseating and covering done. Further work will require cut in and shimming and plenty of finish... Drywall crumbly. Fail GFCI test--not connected to GFCI by sink. Needs to be replaced with GFCI or connected to existing GFCI by sink.

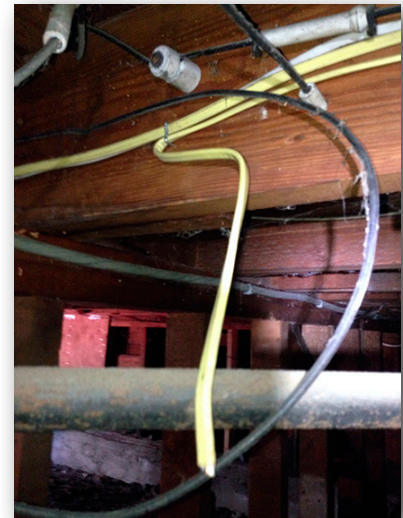
**-result A:** Romex run found to end short of kitchen Subpanel: see pic, I pulled it out. Necessitated work to find alternate solution with existing circuits to avoid opening kitchen wall.

**In order to power living room outlet one new circuit is an option.**

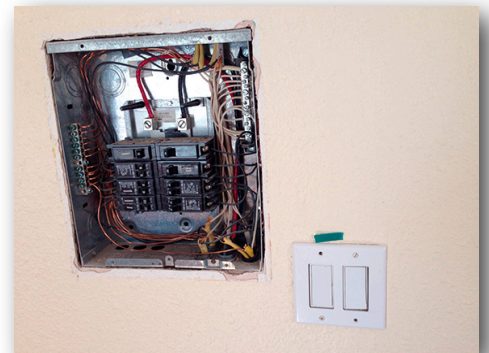
5) *Convert kitchen light switch to dual duplex one switch and one outlet. Necessitated inspection of wire routing and box and availability of neutral. un id'd wires present.*

**-result A:** Drywall crumbly, necessitating more than avg finish time. Switch part of 3 way system with switch on wall near kitchen subpanel. locating neutral not performed.

**In order to complete item 5 neutral must be id'd, pulled, found. 3 way system needs to be managed properly. More id work necessary.**
