Mine and Tunnel Roof Control Products

STRATASCOPE/BOREHOLE VIDEO CAMERA

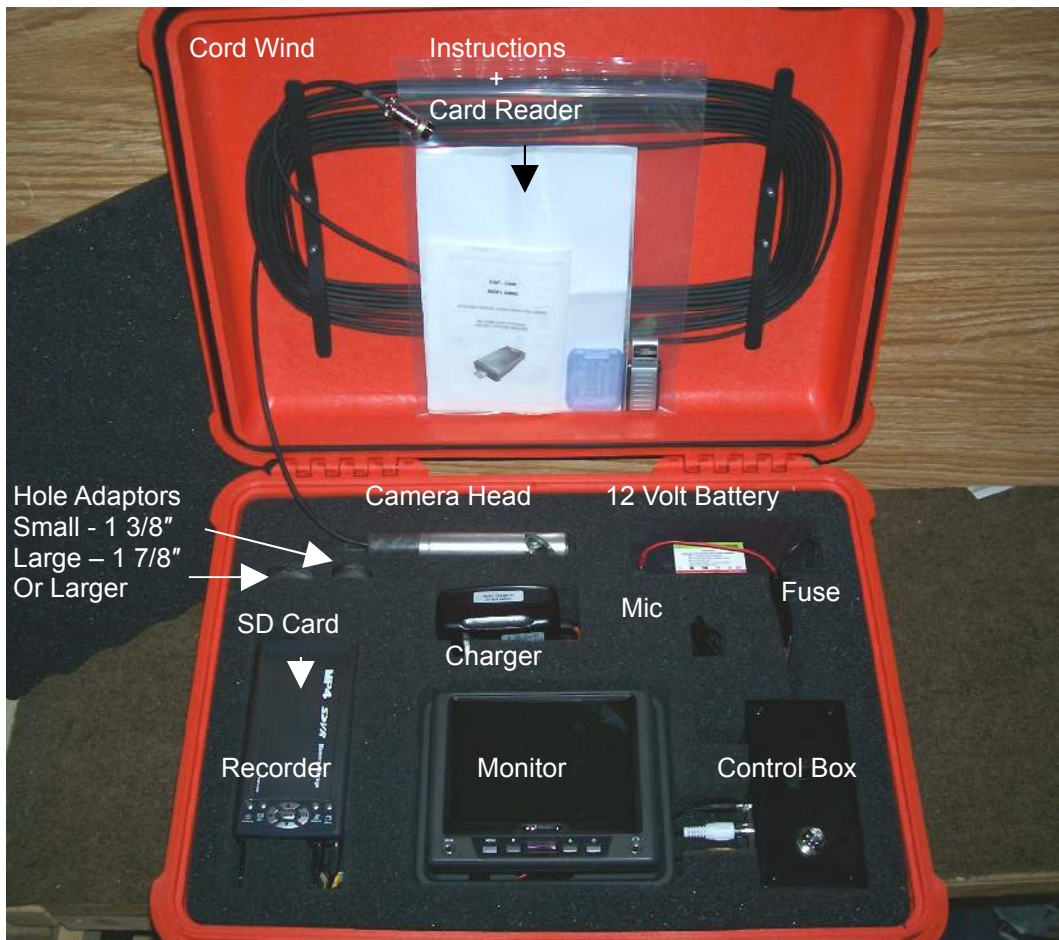
- Watertight, Foam Padded Case
- Bore Hole Camera (For 1" Hole)
- Hole Adaptors (For 1 3/8" + 1 7/8" or larger)
- 12 Volt Battery + Smart Charger
- Microphone
- Flexible, Quick Release Insertion Rods in either 3ft. or 4ft. marked increments
- 5.6" LCD Viewing Monitor
- Digital Video Recorder
- 2 GB SD Card
- Card Reader (Allows easy viewing and storage of files on PC)

CAMERA HEAD

1 AMP FUSE

SONY CHARGER AND POWER CORD

CONTROL BOX

SONY VIEWER

- Miniature video camera with lighting that fits in a 1” diameter hole. (Hole adaptors for 1-3/8” + 1-7/8” or larger).
- Digital Video Recorder with 5.6” LCD viewing monitor, with 2 GB SD card. Microphone included for use in narration.
- Sealed 12V rechargeable battery to run the video camera and lighting. (Charger included).
- Flexible insertion rods marked in one-foot increments, with quick disconnects. Choice of 3ft. or 4ft. segments, plus carrying tube.
- Watertight, sturdy, well-padded carrying case.
- Instructions and operating tips.

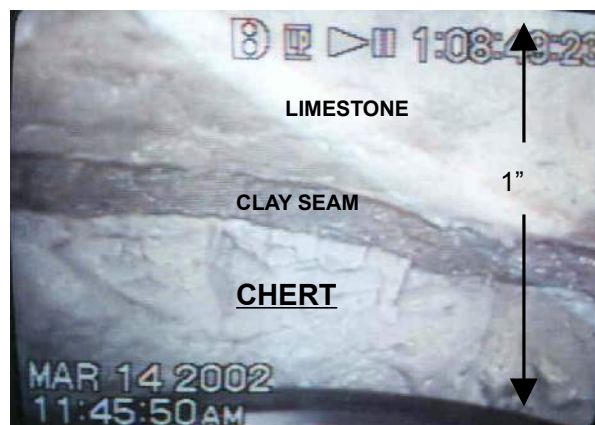
This is a clay seam about 1/8" thick between a layer of limestone and chert. The diagonal light band is a reflection off the TV screen when photographed.
